Re: Request for extension of Final Delivery Date
Lucero Apartments (f/k/a Oak Creek Village) Austin, Texas
Fannie Mae Forward Commitment No.: 874426
PNC Loan No: 310401235

At your request, Wiss, Janney, Elstner Associates, Inc. (WJE) has performed additional assessment of the stucco installation at the Oak Creek Village Apartments buildings, located at 2324 Wilson Street in Austin, Texas. The additional assessment included review of additional information not available to us prior to issuance of our July 22, 2016 report. This letter amends and supplements our previously provided findings and presents recommendations.

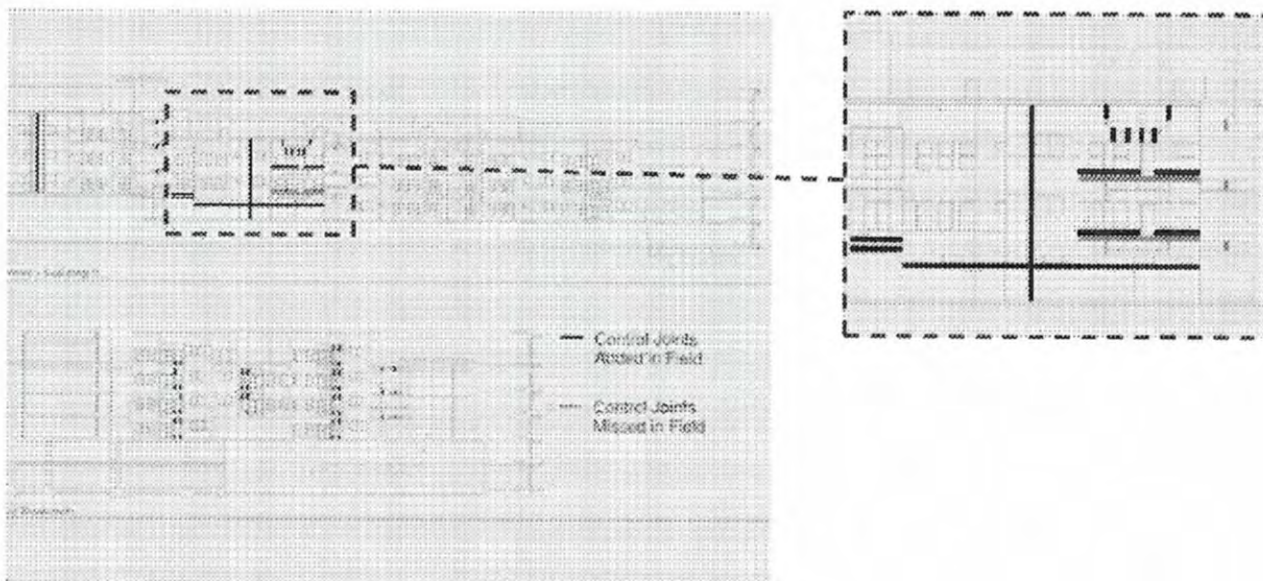
Although WJE, along with the initial design for control joint layout and Keller's suggestion, proposes that control joints be installed at the floor lines, the revised control joint layout produced does appear to generally comply with ASTM C1063 requirements. While the vast majority of control joints installed appear to be located in compliance with the intent of the revised control joint layout, WJE observed that a limited number of control joints were not located as depicted on the revised control joint layout, with several added but some eliminated or relocated (reference Figure 1).

Figure 1. Revised control joint layout per BCS, with construction alterations on Wilson St. marked up by WJE.

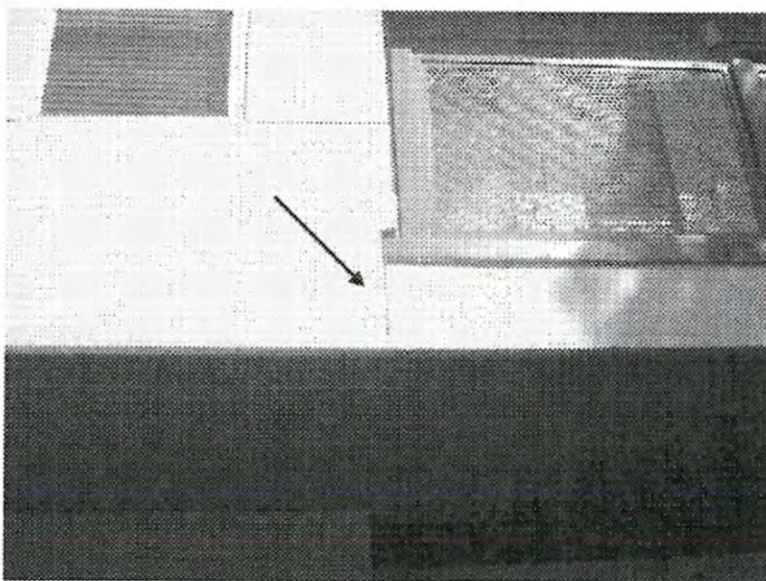
We noted a handful of cracks stemming from the bottom corners of both inset and protruding balconies. Although there are vertical control joints at the inset balcony corners, the function of the joints may have been compromised by Keller extending the lath through the joints, as stated in their submittal amendment and counter to the requirements of ASTM C1063, or fastening both sides of the joints. At the protruding balconies, the revised control joint layout did call for horizontal control joints at the top of the balcony; however, these control joints were instead installed at the bottom of the windows above.

We anticipate some increase in these types of crack over time with additional thermal cycling and building movement. These cracks can allow a larger volume of water than intended to enter through the cladding system, challenging weather barrier vulnerabilities. To mitigate future cracking of this type at locations where the control joints are missing or deficient, stucco could be removed to the nearest adjacent panels in these locations to allow for proper installation of control joints with cut lath per ASTM C1063. Alternatively, cracks could be sealed as part of ongoing maintenance.

Figure 4. Cracking at balcony on Building D despite adjacency to control joint.

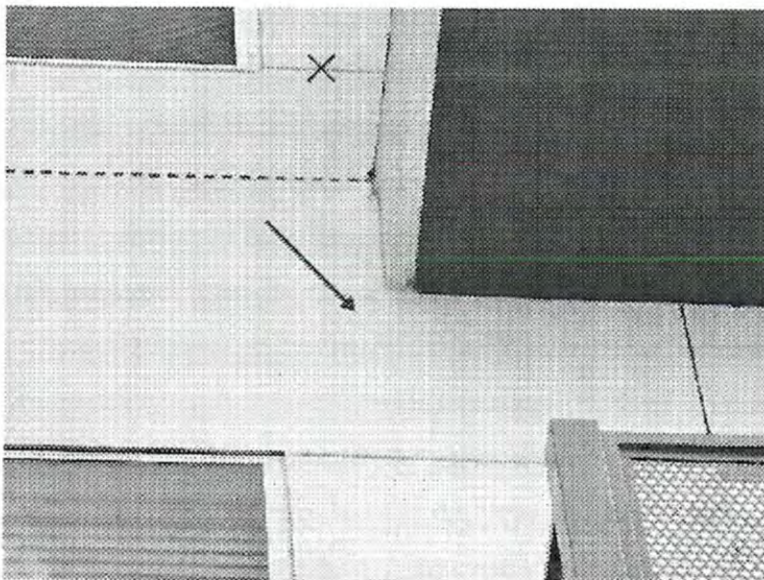
Figure 5. Cracking at balcony on Building A with horizontal control joint not at location indicated by revised layout.

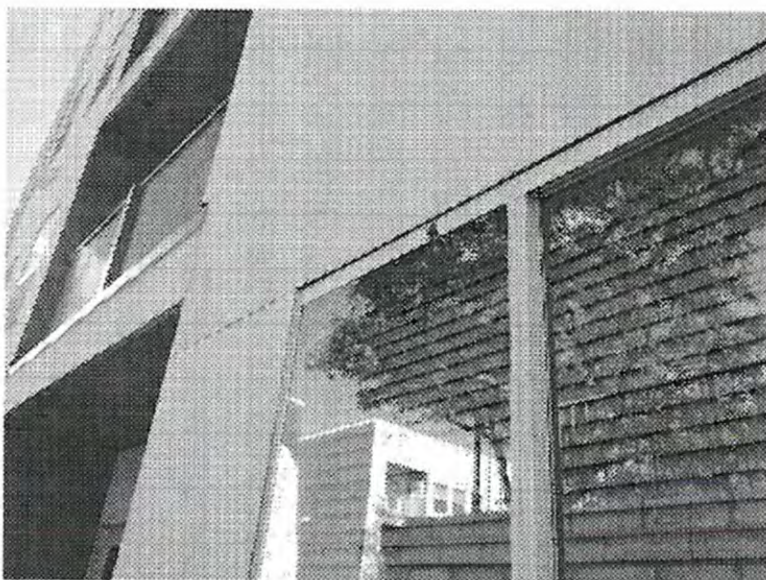
As for weeping the system above the window and door heads, we observed minimal cracks and separations at the heads of windows and doors, and with the head flashing observed as well as the gap between the head flashing and the stucco casing bead above, the wall appears capable of draining at the head locations.

Figure 6. Lack of weep screed at window head. However, head flashing is present and a gap between the flashing and stucco casing bead above will allow for drainage.

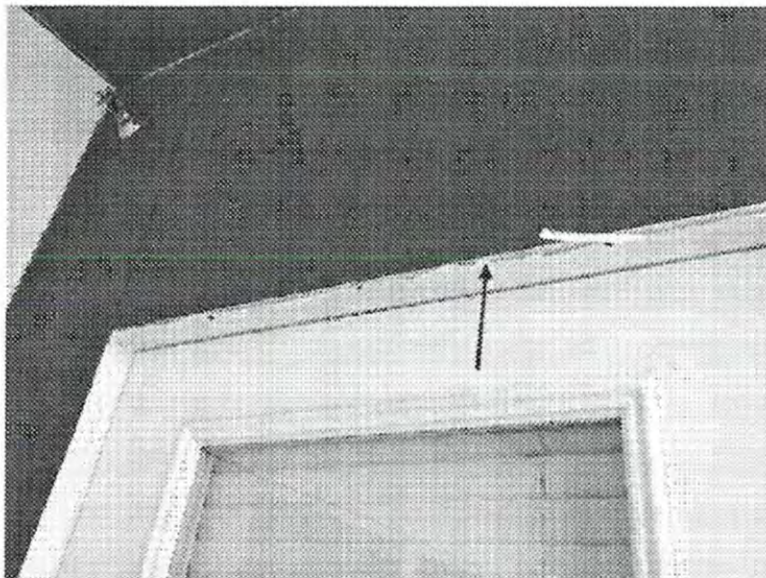
Figure 7. Lack of weep screed at balcony door head, as well as apparent damage to head flashing.

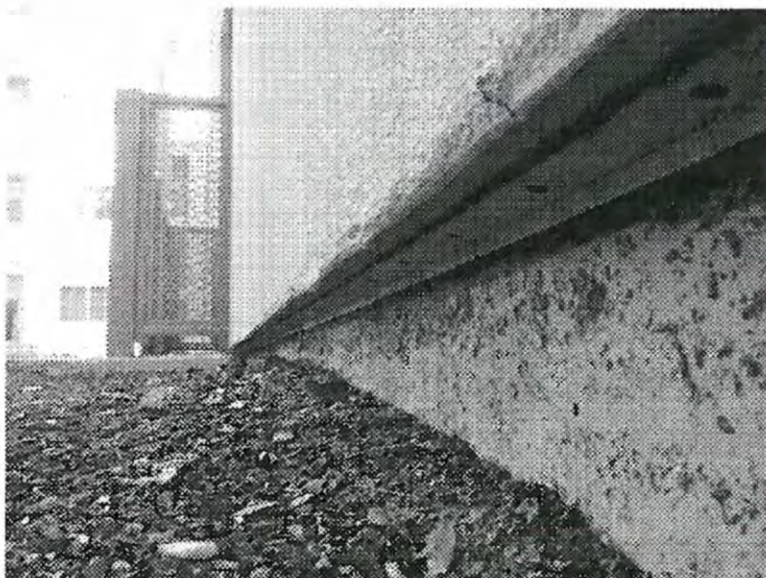
Foundation weep screeds were present at the bases of walls; however, a second piece of trim appears to provide the termination for the stucco, rather than the weep screed. No distress associated with a lack of drainage at the base of the stucco was noted, and the wall does appear capable of draining out from the MTI mat. However, the secondary casing bead used to terminate the stucco does not have its flange engaged with the plaster, per ASTM C1063 requirements. This may contribute to separation of the stucco from the casing bead over time, which, beyond the aesthetic implication, can result in premature deterioration of the stucco termination as well as the accessory over time, as water sheets down the face of the stucco and collects and stands in the non-perforated casing bead. We recommend removing a strip of stucco along these conditions to reinstall the casing beads per ASTM C1063, protect the foam from exposure, and allow the wall system to drain. At a minimum, we recommend monitoring the stucco for separations from the accessories over time and repairing the separations as they manifest.

Figure 8. Weep screed at base of wall not engaging stucco system. Additional non-perforated termination accessory above weep screed.

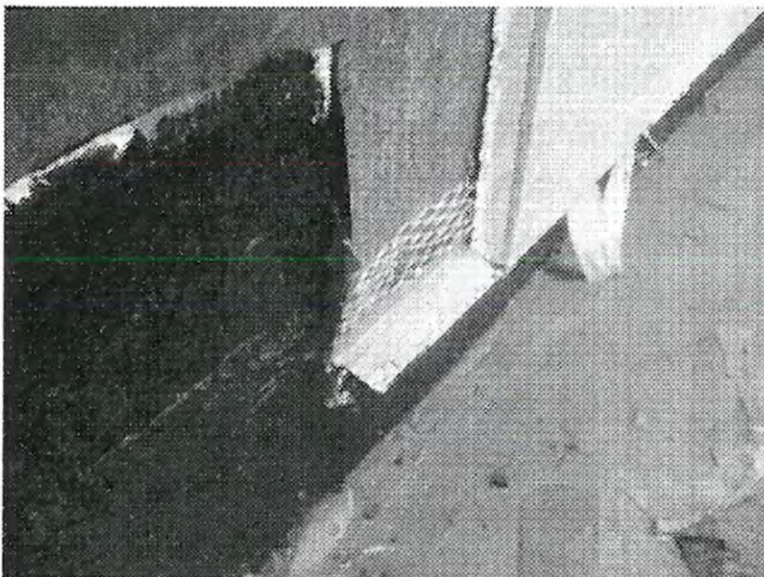
Based on the photos from during construction provided by Weis, the casing beads used at the window and door head and jamb appear to have been installed like the casing bead we observed at the base of wall, with the flange not engaged in the stucco. As a result, separation between the stucco and the accessory can occur with thermal cycling. At the head condition in particular, this can contribute to more water entering the wall system behind the stucco than intended, which is more of a concern at the windows and doors than at the base of wall. We propose a similar repair approach as at the base of wall, removing a strip of stucco around the window and door heads and jambs, reinstalling the casing beads per ASTM C1063, maintaining protection of the foam from UV, and, while leaving the head condition open to drain below the casing bead, reapplying a fillet bead of sealant, with bond breaker tape, between the casing bead and the face of the window framing at the jambs.

Figure 9. Casing bead flange not embedded in plaster.

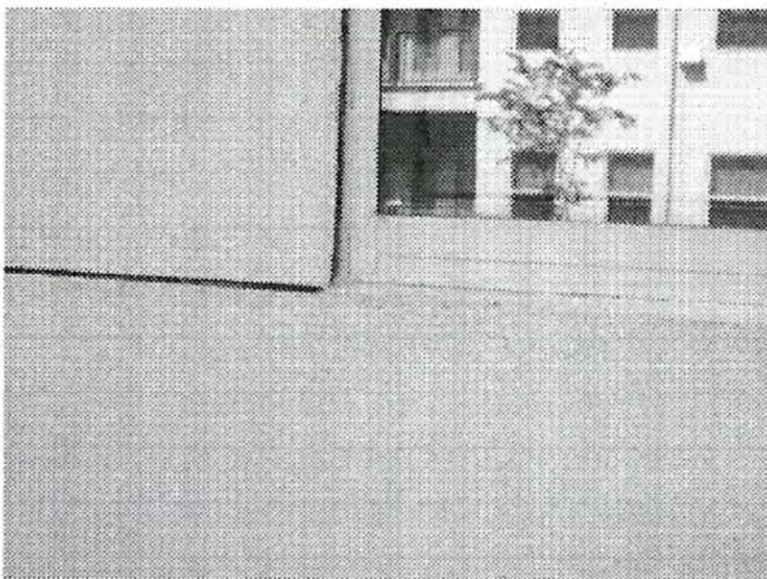
Figure 10. Lack of sill flashing or window framing covering top of stucco assembly.

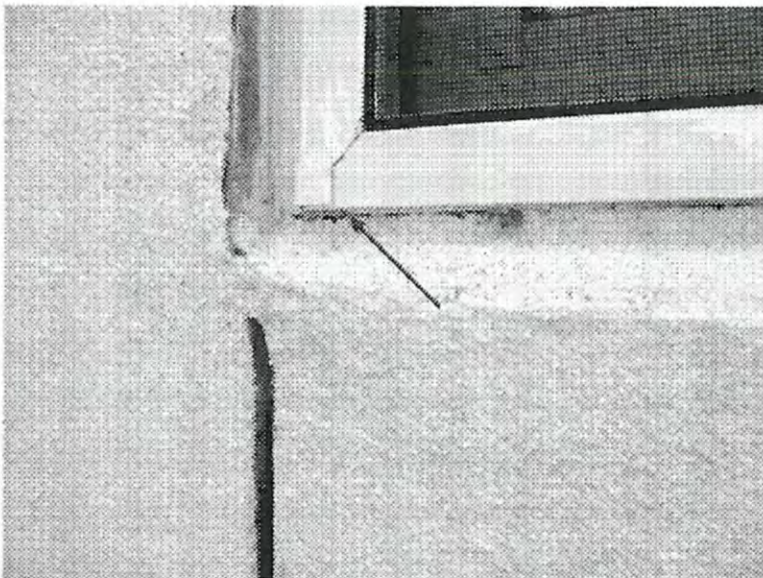
We observed the stucco system returning at an angle to meet the bottom of the windows, and we observed some cracking along the joint between the stucco and window system. As no sealant joint exists to accommodate differential movement of the window frames and stucco system, we would expect additional separation along this joint to develop over time. This separation can allow water to enter behind the cladding system. Although flashings and weather barriers are provided behind stucco, these are intended to manage incidental water only, and measures should be taken to seal openings and gaps that could allow larger volumes of water to penetrate the stucco. Blistering of coatings, efflorescence, lath corrosion, and leakage can all result from excessive water penetration behind stucco. We recommend that stucco below window frames be routed to provide a minimum 3/8-inch joint opening, and that a sealant joint be installed between the stucco and window frame, intersecting existing sealant joints at the jambs.

Figure 11. Separation between stucco and window frame; note lack of stucco termination accessory.

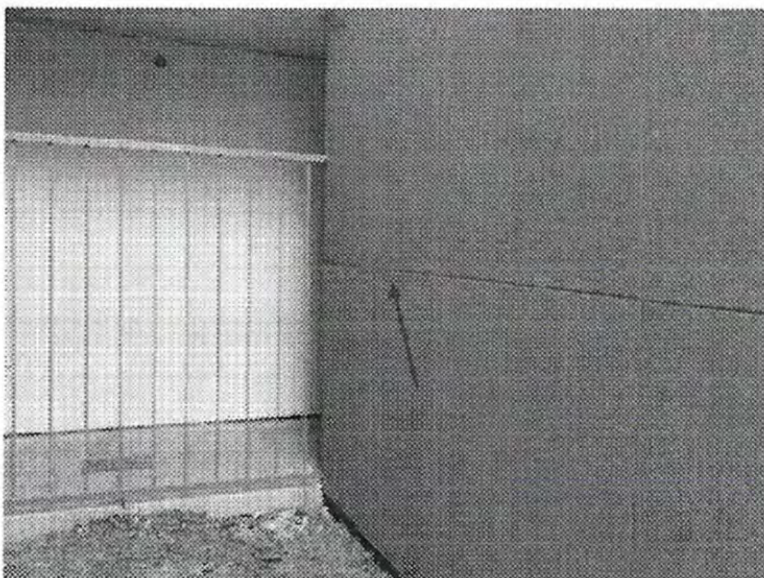
We were able to discern some resulting variation in texture of the stucco finish where repairs have apparently been made. On the east façade, we also noted a couple of panels that had a different pattern of texture relative to adjacent panels, perhaps due to repairs. We are currently unaware of the type of finish

Figure 12. Texture variation apparent at stucco repair on Building B.

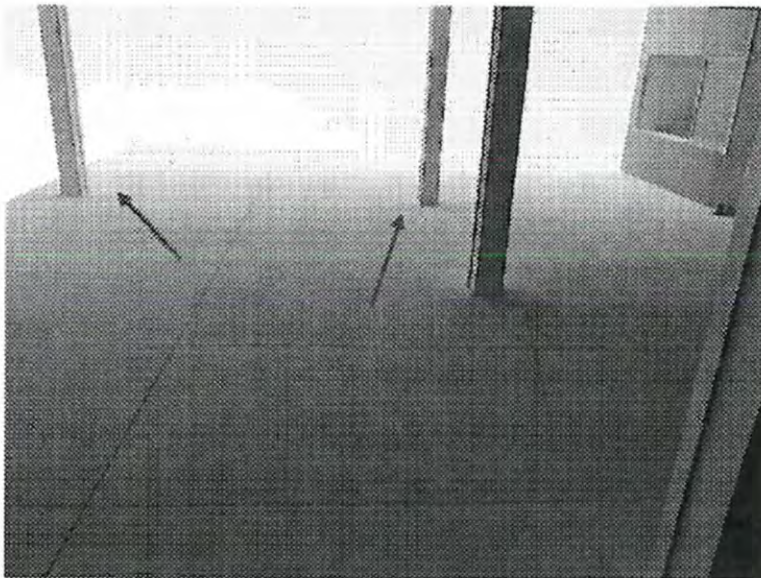
Figure 13. Apparent repairs at beam penetrations on Building C.

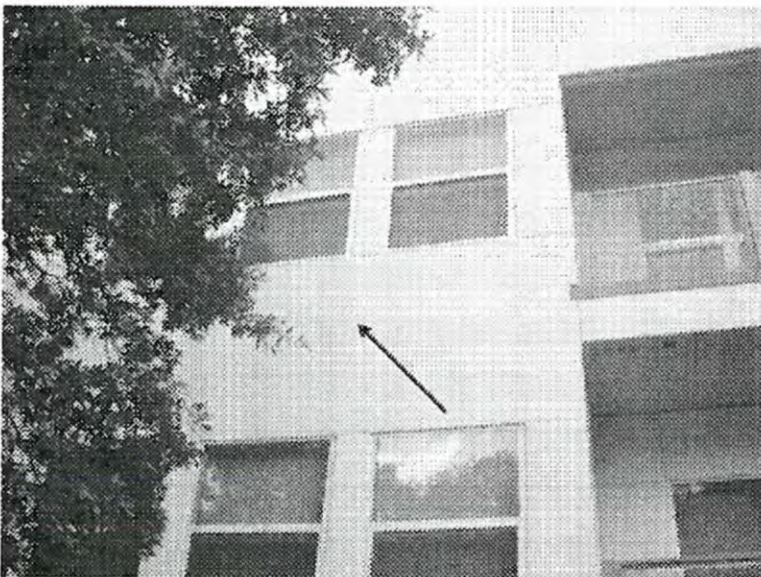
Figure 14. Visible sealant repair at crack on Building C.

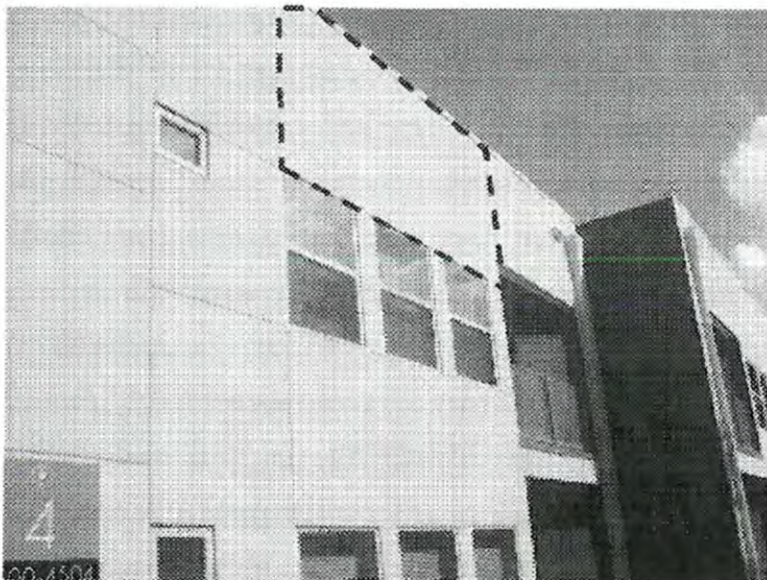
Figure 15. Finish texture at this panel on Building D visibly different from surroundings, though not readily visible from this photo.

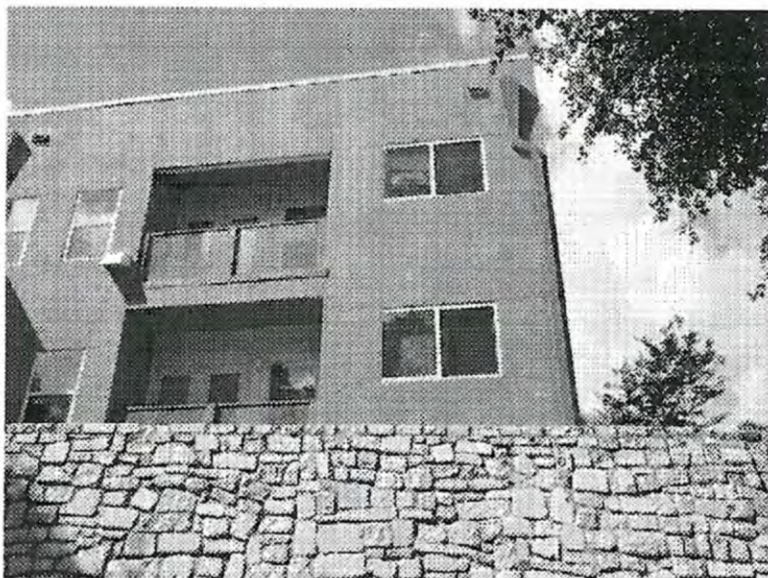
required by the Architect's samples; however, we observed a somewhat rough, textured finish on the installed stucco. The variations in texture are, in general, as expected for a textured stucco finish coat.

Figure 16. Slight overall texture variation on Building B.

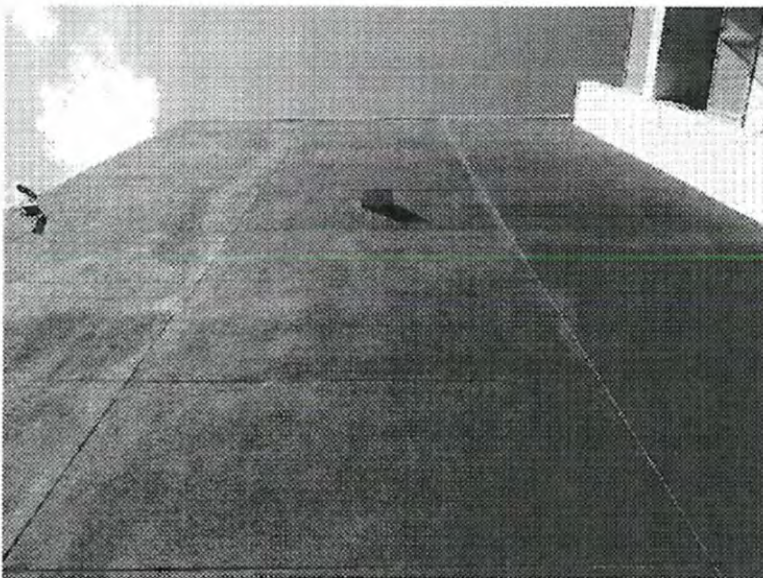
Figure 17. Slight overall texture variation on Building A.

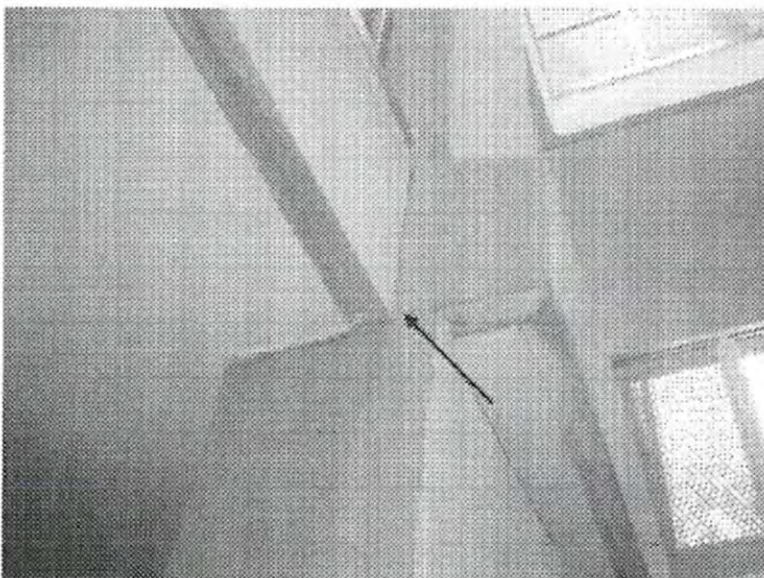
At the columns supporting the breezeways, we observed that the reveal providing for deflection at the top of the column stopped shy of the reglet, making the stucco continuous across the joint at those locations. We also observed corresponding cracking in these locations. Typically, stucco accessories would be provided in these and similar joints to accommodate differential movement of substrates and inhibit cracking between stucco panels.

Figure 18. Crack visible at column adjacent to breezeway where deflection control joint has been filled with stucco.

Continued cracking can be expected at the interface of columns with the breezeways where the stucco is continuous, without a corner bead or other means of separation between stucco panels. To provide separation and accommodate movement, stucco can be cut out to allow for installation of corner casing beads separated by sealant and backer rod. Alternatively, stucco can be routed out along these vertical joints for installation of sealant and backer rod.

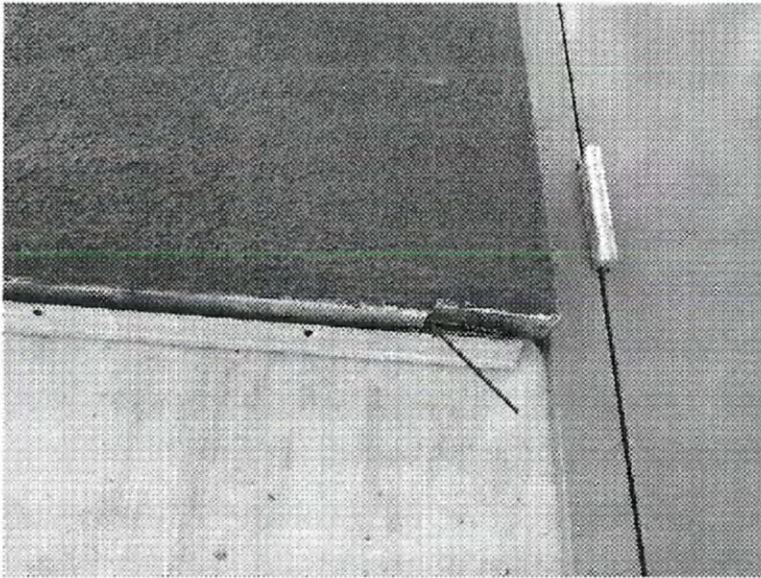
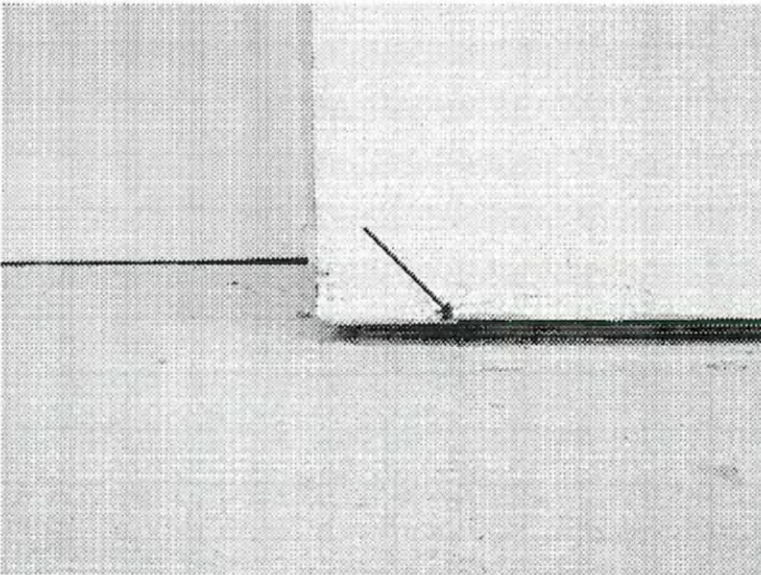
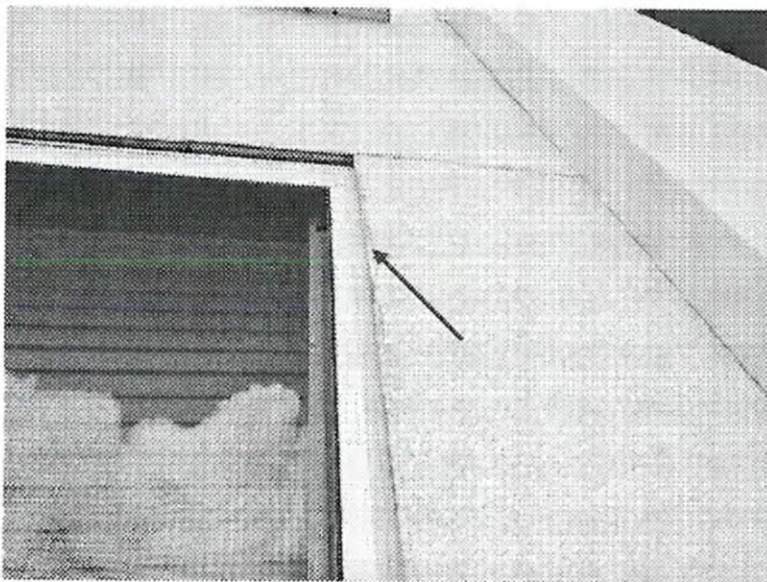
- Separations between stucco and accessories at termination screeds, corner beads, foundation weep screeds, and balcony edges (Figure 19 through Figure 21).

Figure 19. Separation in base trim above weep screed at south end of Building A.

Figure 20. Slight separation in base trim at Building A.

Figure 21. Separation of stucco at jamb trim.

We noted some separation at stucco accessories as well as some uneven terminations at stucco bases, particularly facing Wilson Street and the interior courtyard. The separations can be repaired with sealant and sanded and painted to match the existing stucco. At the uneven terminations, the stucco panel at the base of wall can be removed and replaced.

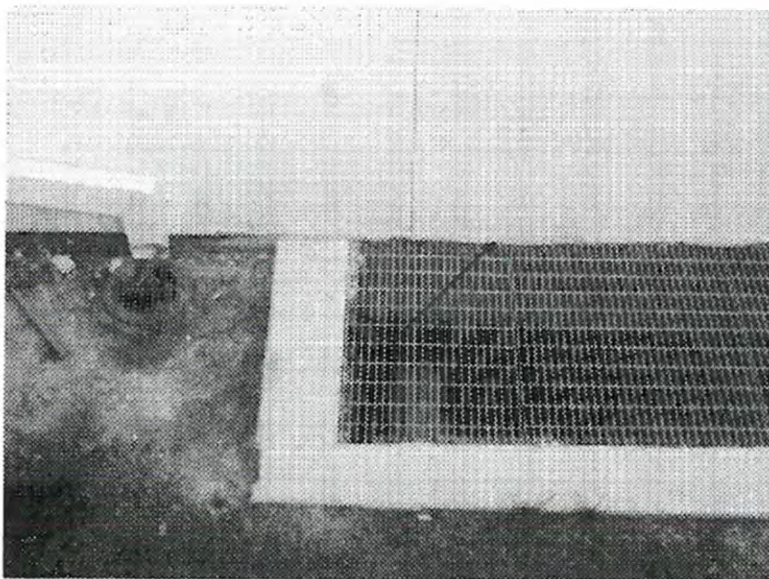
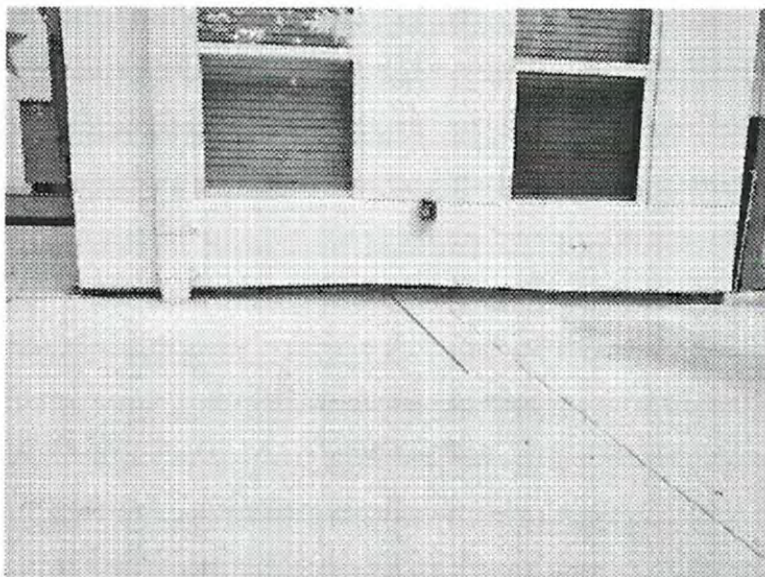
- Uneven termination of stucco at edges and bases of walls (Figure 22 and Figure 23).
- Cracking in the field of stucco and along the wood column between Buildings C and D (Figure 24 through Figure 28).

Figure 22. Uneven termination of stucco at wall base above garage vent on east side of Building C.

Figure 23. Uneven termination of stucco at wall base above garage vent on east side of Building A.

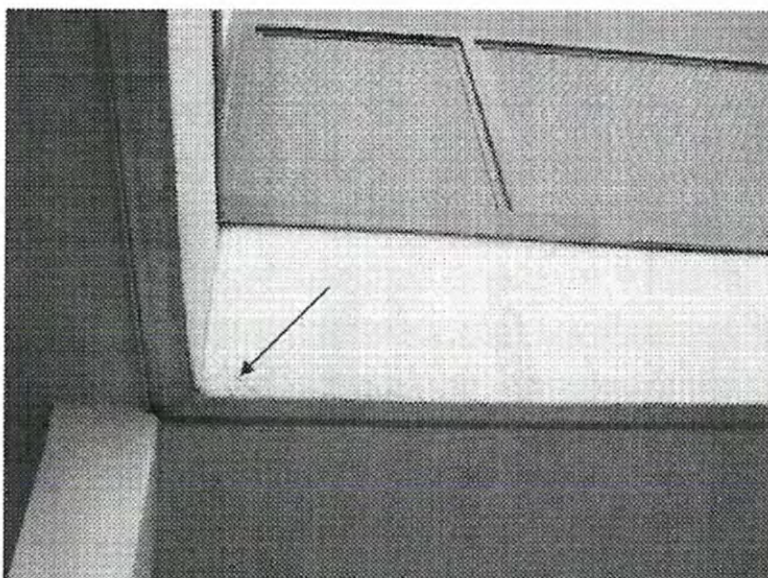
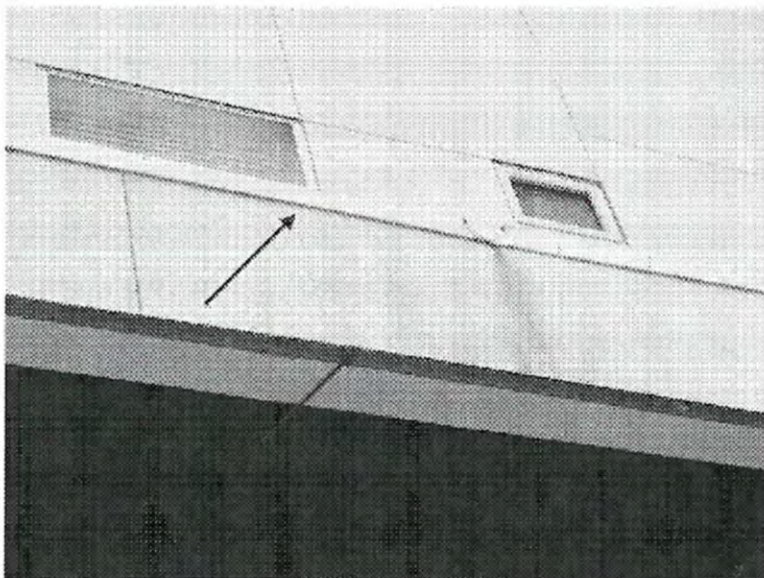
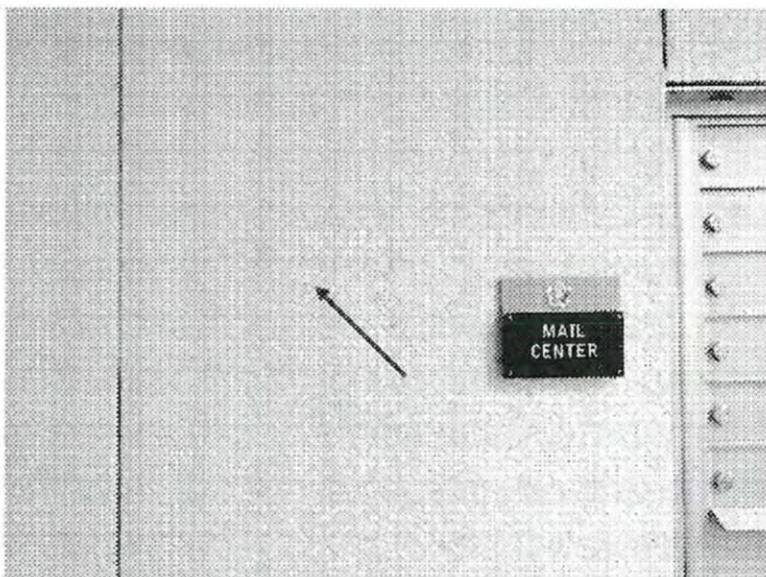
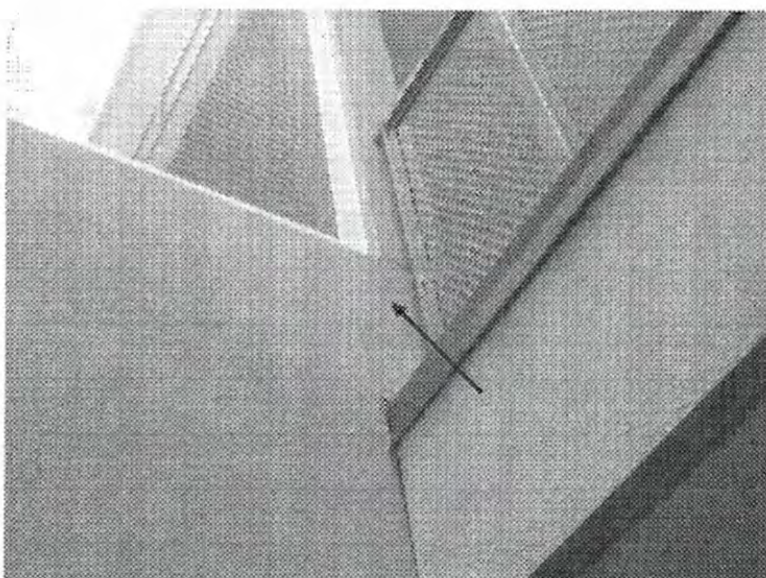
We observed some isolated cracking in the field of the stucco as well. As described above, this cracking is limited, likely related to the failure to cut the lath behind control joints and/or placement of control joints in locations inconsistent with those recommended in ASTM C1063, *Standard Specification for Installation of Lathing and Furring to Receive Interior and Exterior Portland Cement-Based Plaster*. This standard contains recommendations for locating control joints, including provision of horizontal and vertical joints at each window and door corner as well as limiting the length-to-width ratio of each stucco panel to 2.5:1. These standards generally appeared to be followed on the revised layout and as constructed, with the exception of some isolated locations noted above. These isolated cracks observed can be repaired with sealant and sanded and painted to match the existing stucco.

Figure 24. One uncontrolled crack and staining visible at breezeway on Building C.

Figure 25. Crack above splice in stucco accessory.

Figure 26. Hairline crack near Mail Center signage.

Figure 28. Small crack at base of window near breezeway; note lack of vertical control joint.

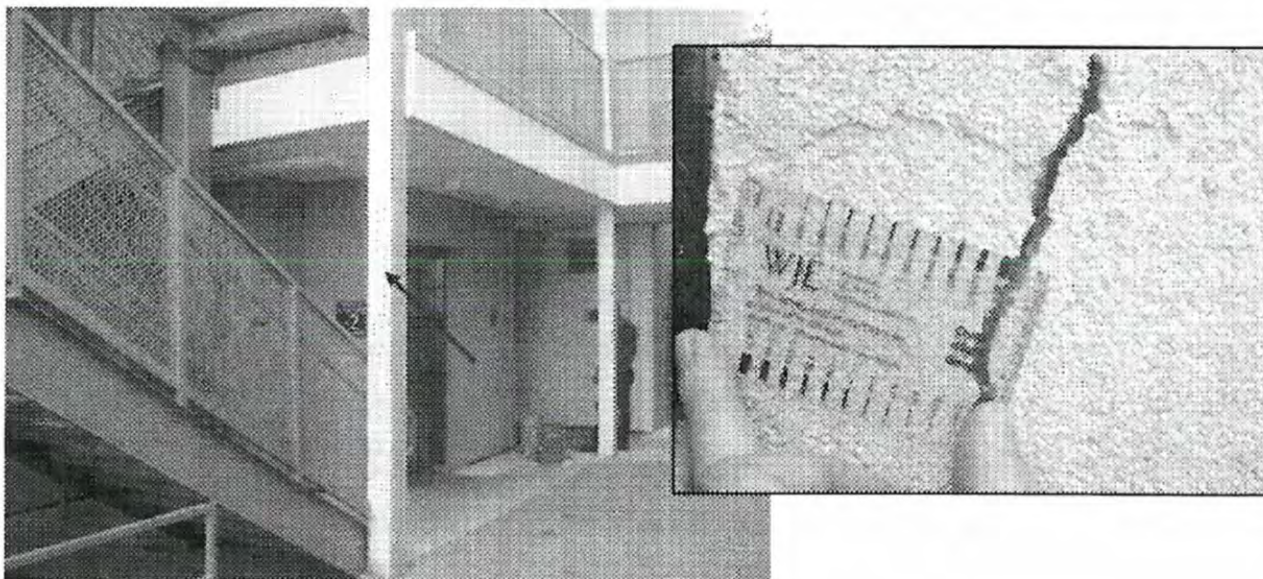
Figure 27. Cracking on all sides for much of height of column at Building C.

A purportedly wood column between Buildings C and D exhibited cracking almost its full height. WJE recommends complete removal of the stucco, installation of membrane flashing over the extents of the wood, and covering the column with formed sheet metal panels or similar to match the surrounding stair. We do not recommend reinstalling stucco in this location, given the geometry of the column and potential for future cracking with moisture content-related volume changes in the wood.

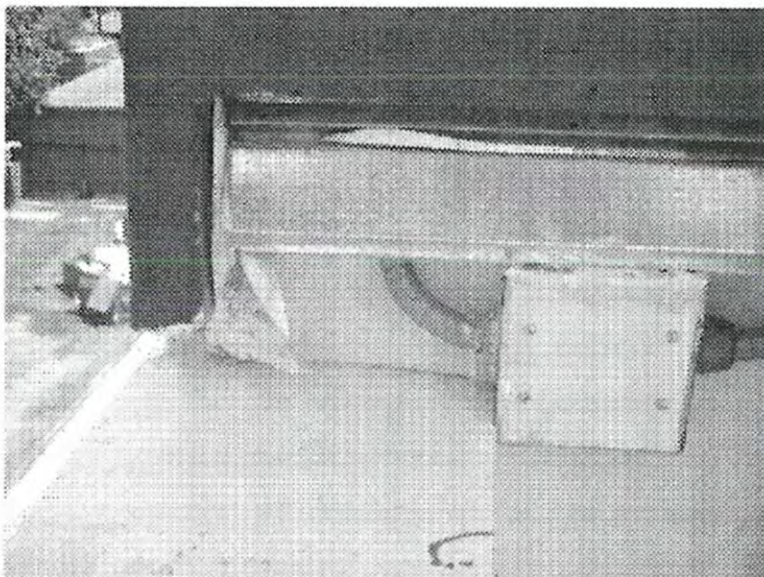
Figure 29. Lack of sealing of weather barrier at wall base on roof of Building A.

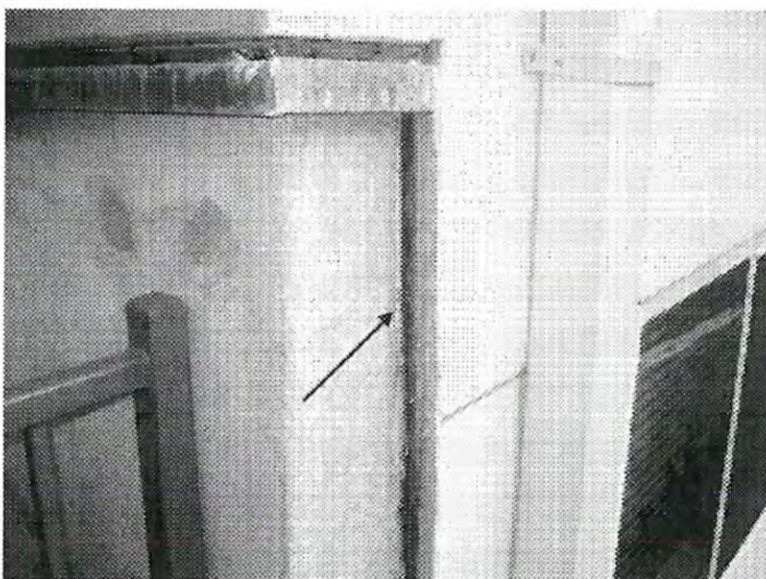
Figure 30. Exposed Tyvek tape unsealed at exposed concrete on Building C.

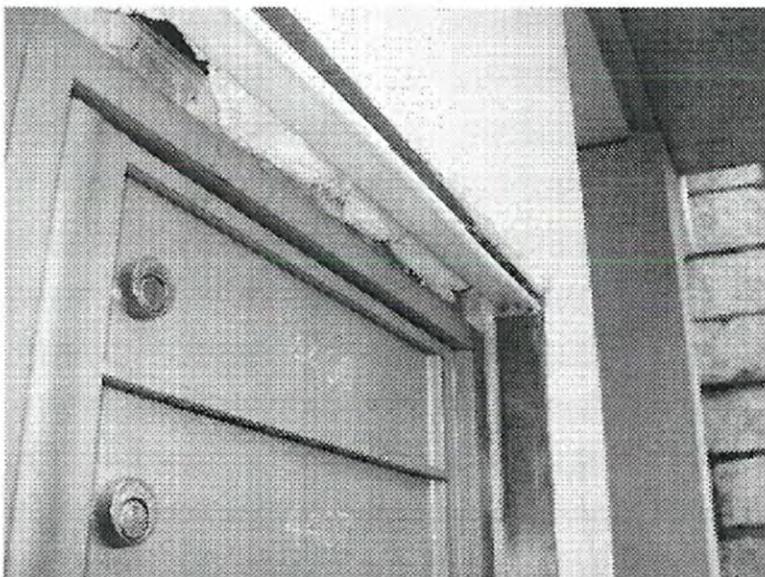
Figure 31. Lack of weather barrier tie-in at sheathing above mailboxes at Building C.

interfaces at Building A. At the mailboxes, both the stucco and mailboxes should be removed to allow for installation of membrane flashing into the perimeter of the rough opening to ensure continuity of the air and moisture barrier system. **Sheet metal closures may be required at the perimeter of the stucco opening around the mailboxes.**

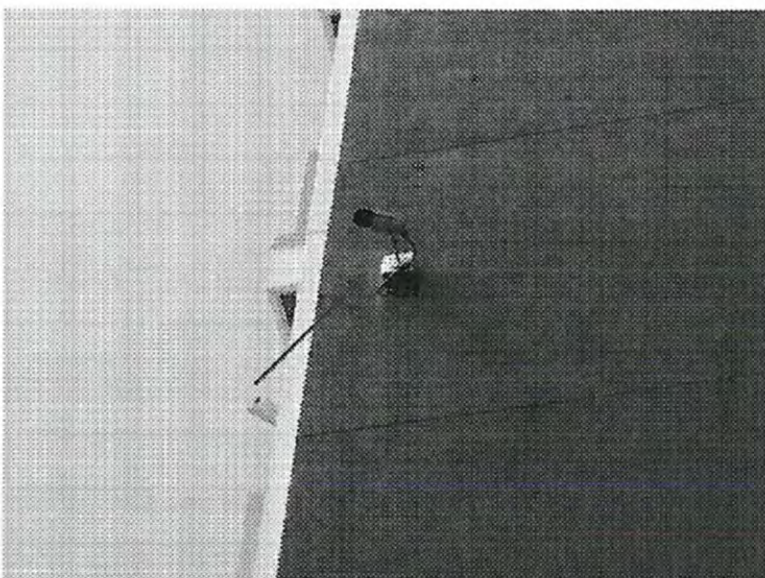
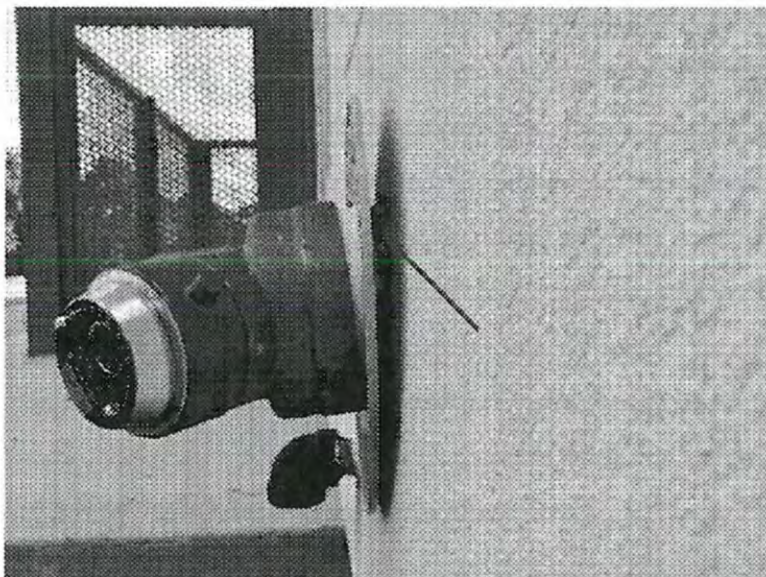
Figure 32. Damage visible at security camera on Building A.

Figure 33. Fire hose spigot penetration not sealed at face of stucco on Building A.

We also observed a number of penetrations through the stucco that did not appear to be sealed and one location where the sealant had separated. In locations of apparent lack of continuity between the weather barrier and adjacent opening or roof system, water can leak into the building interior, leading to damage of wall components and finish materials. At locations of unsealed penetrations, it was unclear if the penetration was added subsequent to installation of the stucco; penetrations added after stucco installation may not be adequately integrated into the weather barrier system, **which can also lead to water infiltration. We recommend adding sealant to the untreated penetrations and repairing any separated sealant.**

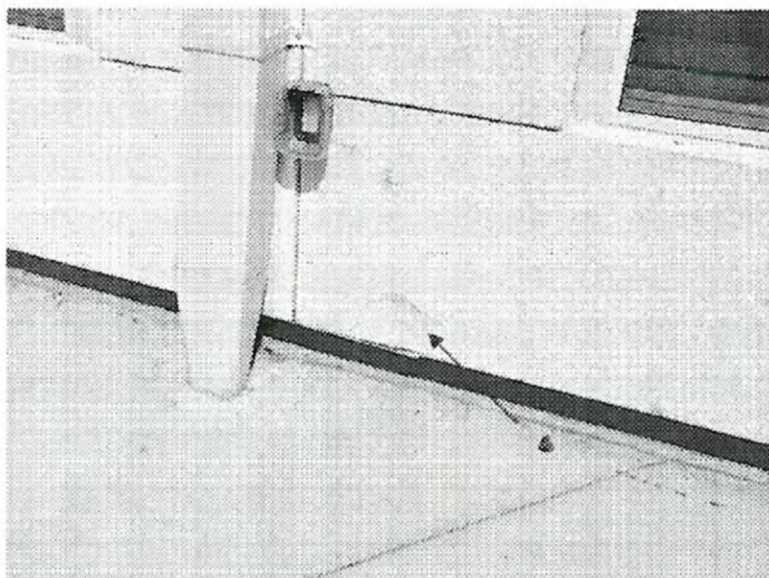
Figure 34. Mechanical damage to stucco on Building A.

In a limited number of locations, we observed mechanical damage to the stucco. These areas should be repaired and recoated.

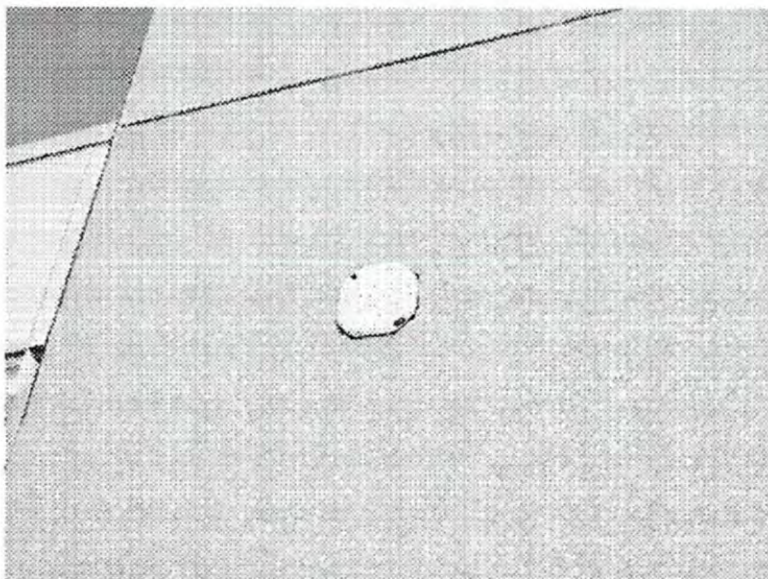
While not necessarily problematic, we did observe a few instances of what appeared to be abandoned electrical junction boxes with unsealed covers penetrating the stucco. A lack of continuous cladding material at damaged stucco and abandoned unsealed junction boxes can allow water to enter into the wall system, potentially leading to leakage at the building interior. It is unclear whether the abandoned outlets are contributing to any water intrusion behind the stucco; however, we recommend considering installing permanent exterior covers that can then be sealed to the stucco. In addition, we recommend continued monitoring of the area interior of unsealed penetrations to determine whether water infiltration is occurring as a result of these installations.

Figure 35. Abandoned electrical junction box with unsealed cover on Building A.

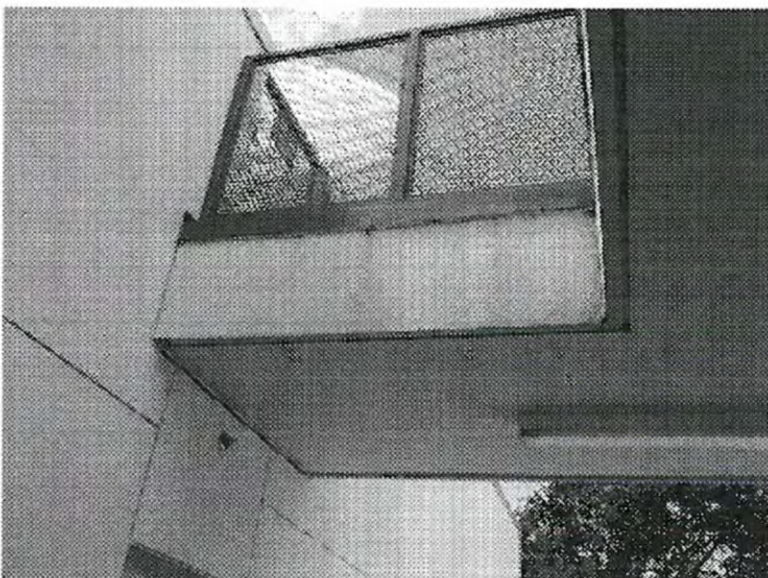
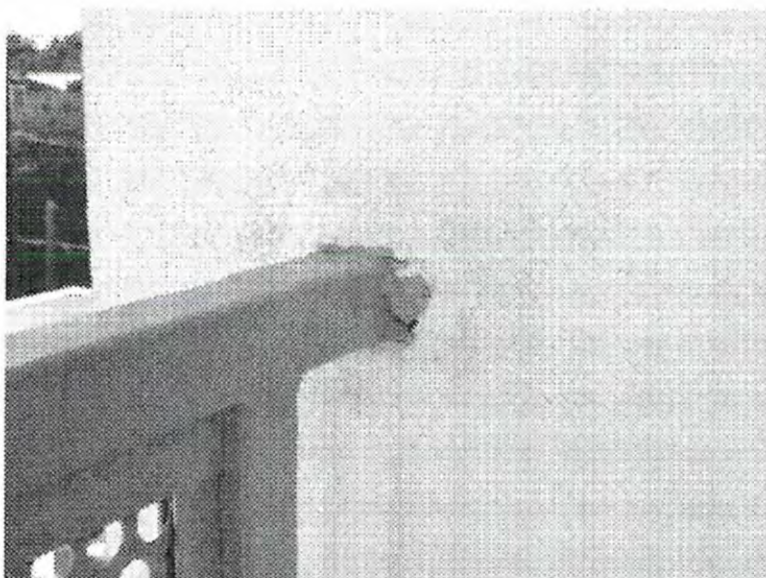
WJE observed widespread staining of the breezeway and balcony fascia conditions as well as signs of corrosion at several instances of the railing where we presume some portions of the railing were not fully coated. Beyond the resulting staining, this also appears to be contributing to some spalling in the balcony concrete where the railing posts are encapsulated. Further corrosion of handrails will lead to additional spalling of the surrounding concrete, due to the expansive nature of the corrosion product. In at least two locations on Building A, we also observed staining below balconies at either end, which appears to be resulting from the railing corrosion. Staining on the surface of stucco below balconies and walkways can be removed with a mild cleaner such as tri-sodium phosphate and a stiff bristle brush. However, strong cleaners and acids, such as muriatic/hydrochloric acid, should be avoided to prevent damage to the stucco. Regular cleaning of the balcony surfaces may limit the recurrence of this staining; however, stucco surfaces will likely require continued cleaning. Resolving the railing corrosion issue (discussed below) will likely minimize the cause of some of this staining.

Figure 36. Typical staining at breezeway fascia due to moisture runoff.

Figure 37. Corrosion of railing behind stucco resulting in staining at balcony on Building D. Sealant not provided around penetration through stucco.

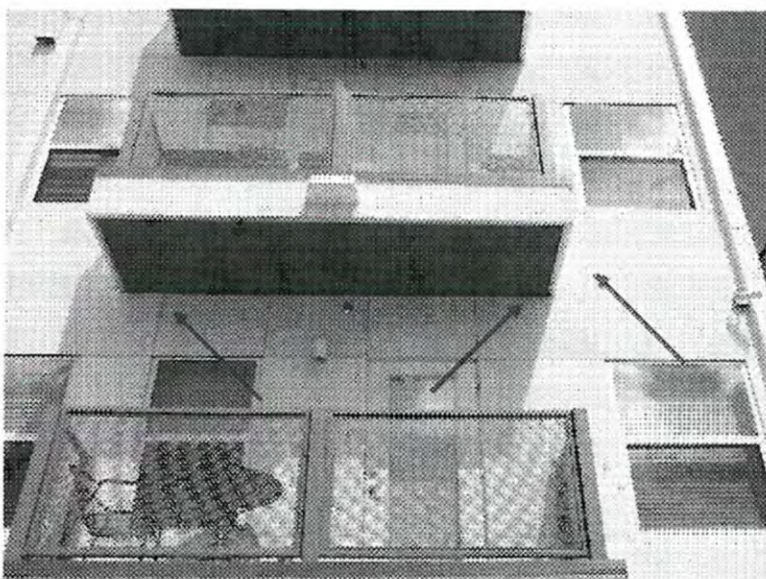
Figure 38. Abandoned electrical junction box (blue) and undiagnosed staining (red) below balcony on Building A.

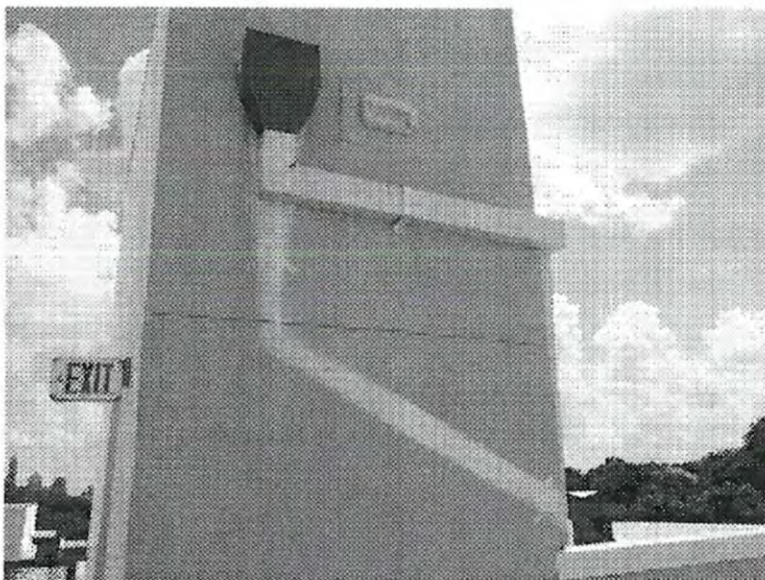
Figure 39. Relocated downspout reveals lack of coating and abandoned fastener penetrations in stucco.

Where one downspout was relocated at the base of Building A, the stucco surface was not coated, and abandoned fastener penetrations were present. The penetrations should be repaired, and the stucco and utilities should be painted to match adjacent panel colors.

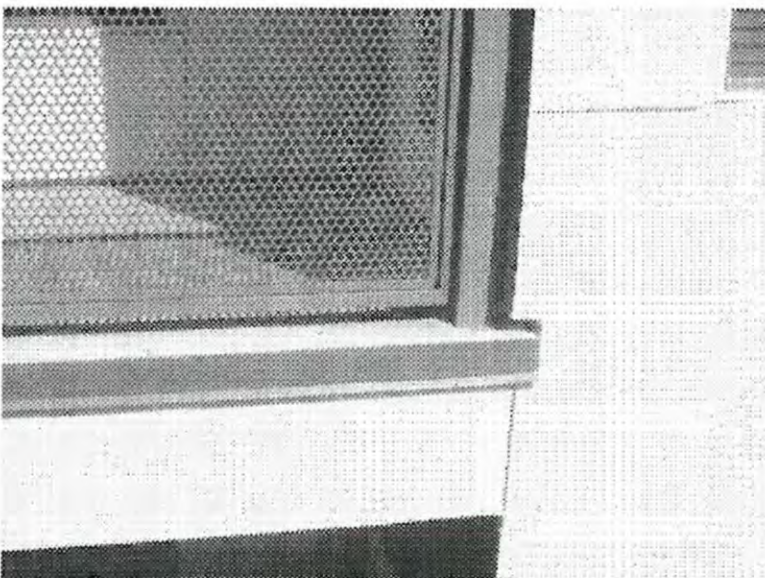
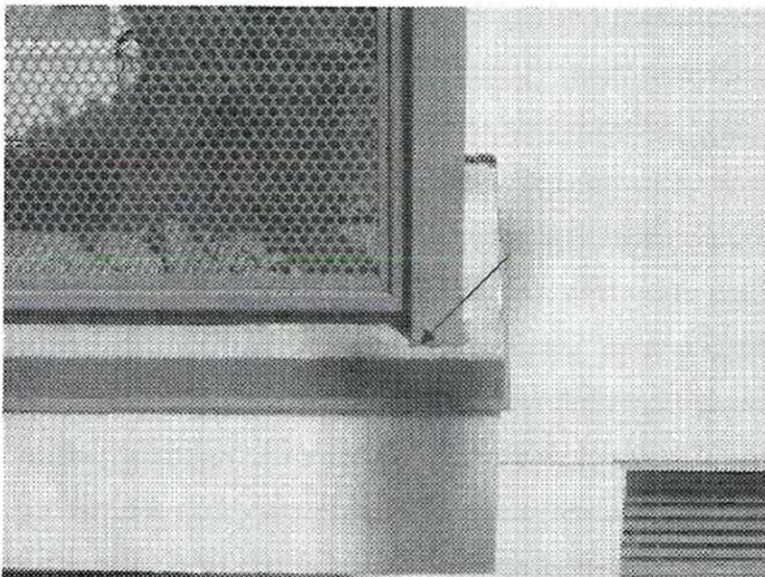
Figure 40. Corrosion of presumably uncoated portions of railing mesh noted in several locations.

Figure 41. Spalling of concrete at balcony where railing does not appear to be fully coated.

We recommend cleaning the railings where corrosion is already occurring and applying a protective coating to mitigate any further corrosion. Depending on the extents of corrosion, the railing may need to be removed to allow for continuous application of the coating over embedded rail post surfaces. Without isolation joints

around the posts, cracking and spalling may occur due to shrinkage and thermal movement of the topping. We recommend providing full-depth compressible joint filler material with surface sealant joint around railing posts and a 3/8" sealant joint around railing penetrations through stucco. **Subsequent to these repairs, corrosion staining can be removed from the faces of the stucco.**
